# **AN ANALYSIS OF THE GenFixx™ MECHANICAL ASSEMBLY TECHNIQUE COMPARED TO A BRAZED ASSEMBLY TECHNIQUE USED IN SEVERE SERVICE VALVE COMPONENT APPLICATIONS**

**General Carbide|UK, Daventry, England**

**August 2011**

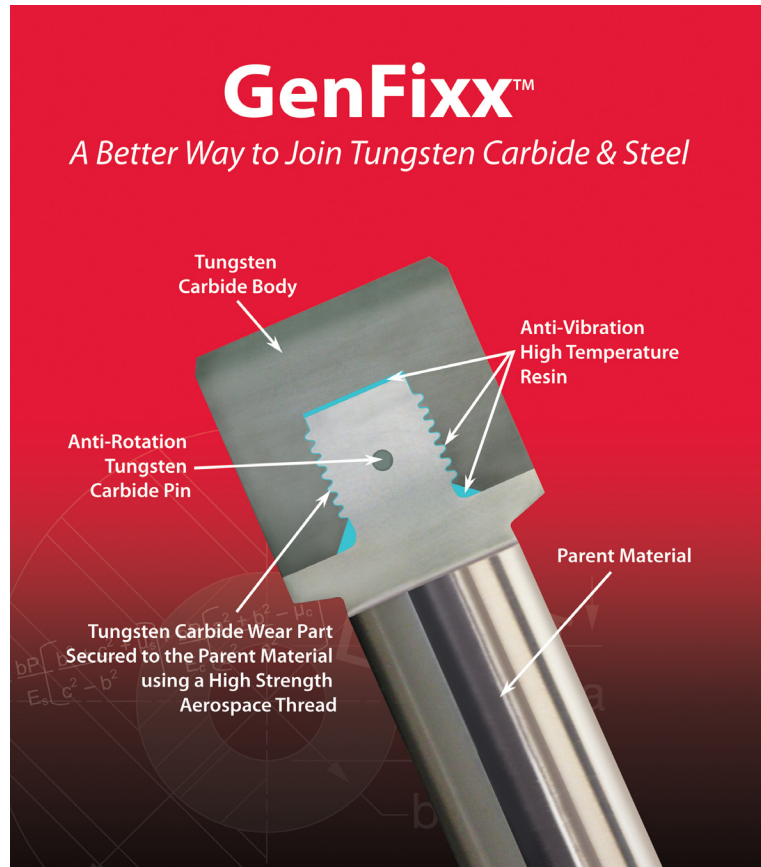
(Figure 1 – GenFixx)

The GenFixx technique (patent pending) employs the use of an internally- or externally-threaded tungsten carbide component mated to a threaded steel body with high temperature epoxy added to resist vibration. The component is also reinforced by a tungsten carbide pin inserted laterally for anti-rotation protection (See Figure 1.)

The laboratory conducted static tensile tests on three specimens each of brazed and GenFixx assemblies, as shown in Figure 1.

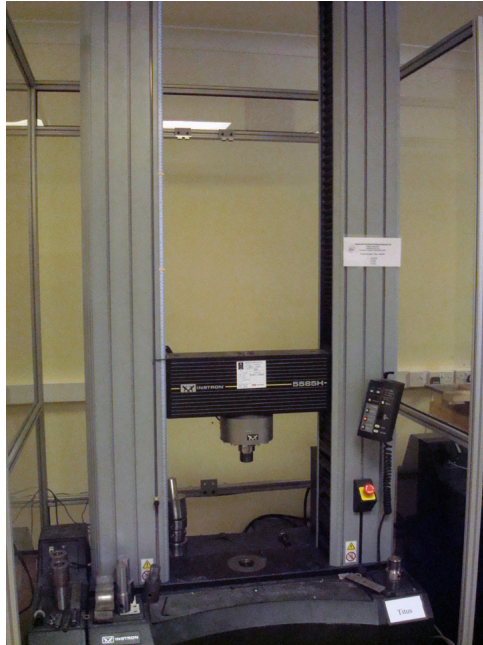
(Figure 2)

The tests were conducted under strict laboratory conditions using an Instron 250 kilo Newton tensile test apparatus (Figure 2). The technician set the Instron machine to operate at a speed of 1 mm/minute to pull apart the brazed assembly specimen in tension with the intent to sever the braze joint and measure and record the load needed to accomplish shearing of the three specimens. It was likewise intended to pull the GenFixx specimen apart in tension by stripping the threaded, pinned and epoxied joint, and measure the load needed to accomplish that on the three specimens.

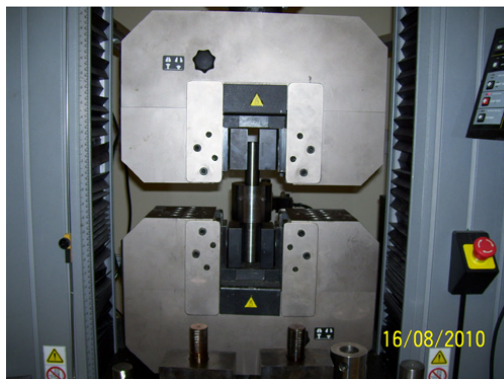
(Figures 3 and 4)

The carbide end of the specimen was modified by grinding two 4.5mm radius grooves in it, allowing two steel pins to nest in the grooves, which would create the gripping points for the machine on the carbide end. The steel end was gripped by inserting the threaded shaft into a mating thread on the gripping fixture. (See a similar fixture method shown in Figures 3 and 4.)

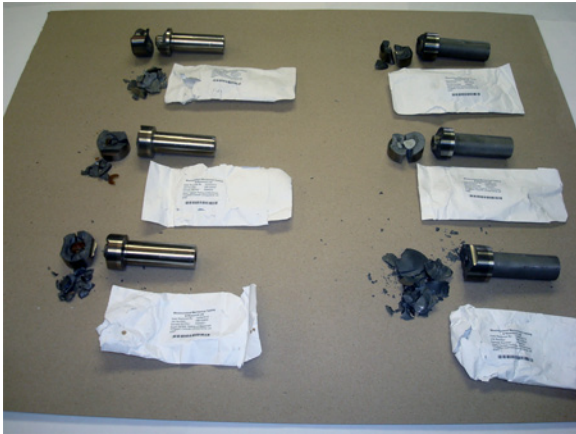
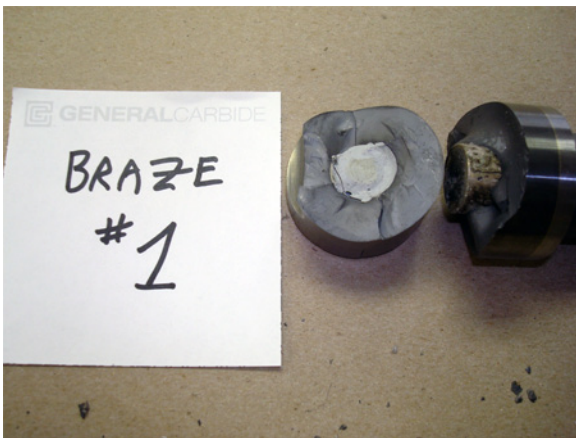
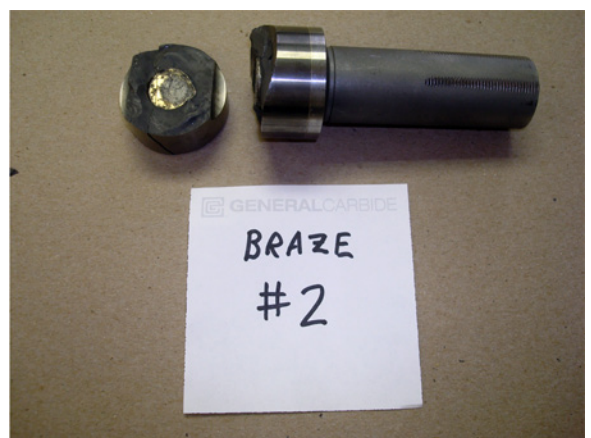
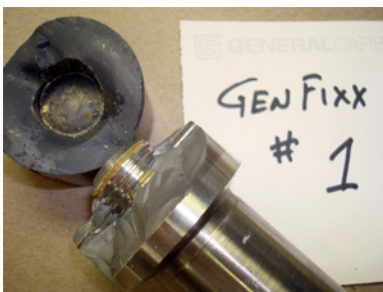
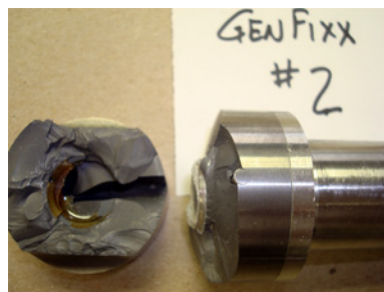
(Figures 5(a) through 5(g))

The photos of the failed test specimens of each type are shown in the Figures below.

By examining the failed carbide/steel assemblies, it was revealed that the static tensile test did not actually determine the strength of either joint because the carbide material failed in tension at a location above or around the joints in all six specimens. In the GenFixx assemblies, the cross pin was intact in all cases and can be readily seen in Figures 5(e) through 5(g). In addition, most of the carbide threads are still engaged, but the surrounding material is fractured. In the brazed specimens, the joint is intact, but the surrounding material failed. Thus, neither the brazed assembly joint nor the GenFixx assembly joint failed in any of the tests.

Because cemented carbide is known as a "brittle" material, it does not demonstrate a high degree of tensile strength, and the measured values are not surprising. As a brittle material, cemented carbide also adheres to Weibull's Statistical Strength Theory, which explains the influence of micro-porosity as stress concentrations on the strength of all brittle materials. A brittle material will not exhibit plastic deformation preceding the initiation of a crack. A crack, however, could be initiated by a micro-void in the material, or by a stress riser such as a sharp corner or radius ground into it. Thus, the gripping technique for the tensile test for the carbide must not be allowed to be, in and of itself, a site of crack origination due to a stress concentration created by the gripping grooves. It was thus proven that the gripping technique was not a factor in the test results.

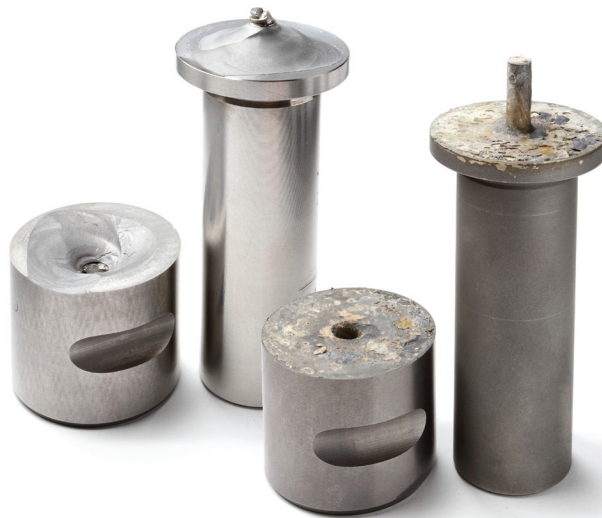
(Figure 6)

Figure 6 shows the failed specimens, one GenFixx and another brazed .

It is interesting to note that the failed brazed specimen exhibited total "wetting" of the braze material on all joined surfaces, including the pin area. Although it was a "good" braze joint by all standards, it is a determination that one is unable to make unless the joint is destroyed.

*The GenFixx specimen displayed 1% greater break strength than the equivalent-size braze joint, a small but significant difference.* A portion of the carbide threads were, in fact, pulled apart exposing the cross pin which did not shear but the strength of the threads in tension surpassed the shear strength of the braze material on the pin surfaces, as well as the pure tensile strength of the braze material on the mating carbide plug surface. Thus, the results show that GenFixx is stronger than an equivalent braze joint.

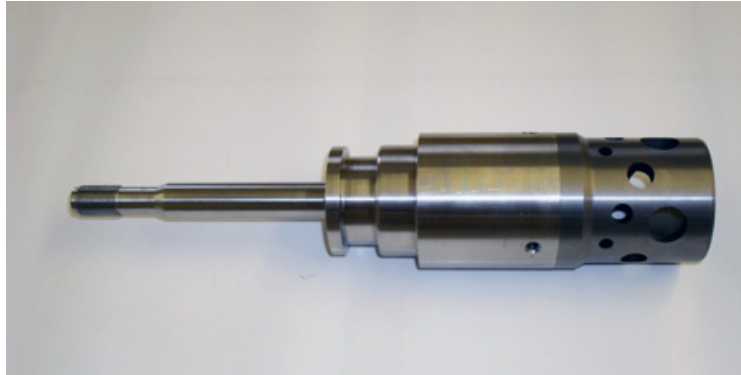
(Figure 7)

The practical application for such an improved fastening technique such as GenFixx may be seen in Figure 7 below.
